TECHNICAL MEMORANDUM

Date: December 15, 2011 **Project No.:** 013164611A.800

RE: COMPLETION OF ISOLATION PAD, BUILDING 2-88

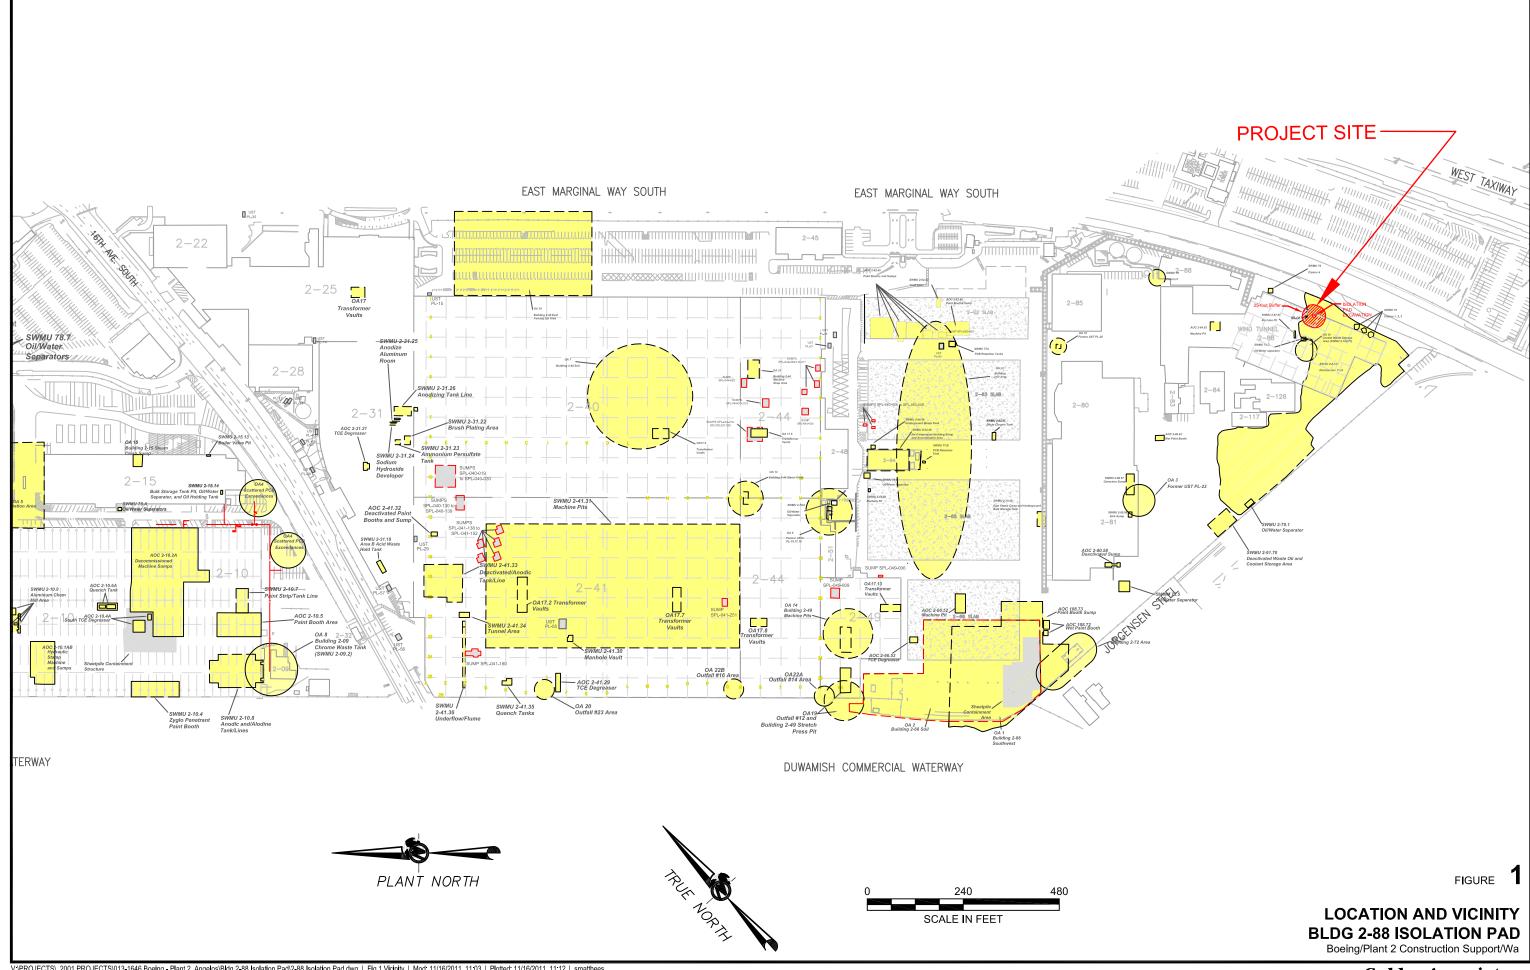
- Figure 1 Location and Vicinity, Bldg 2-88 Isolation Pad
- Figure 2 Bldg 2-88 Isolation Pad Excavation Area

The Boeing Company (Boeing) completed concrete removal and grading activities associated with the construction of an isolation pad in Building 2-88 at Plant 2 in late November (Figures 1 & 2). The new isolation pad was installed as the foundation for a new machine. The project required the demolition and removal of a 6-foot wide by 8-foot long section of concrete flooring and foundations, re-grading of the bedding materials beneath the concrete, and placement of concrete for the new isolation pad that measures approximately 5.2 feet wide (east to west) by 7.3 feet long (north to south) by 18 inches thick.

A preconstruction review of historical analytical data indicated that one boring (SB-08715) was completed in 1995 within a 25-foot radius of the location of the isolation pad (Figures 1 and 2). Soil samples were collected in the boring at depths of 2, 7, and 9.5 feet bgs. No groundwater samples were collected.
